JHRP-76-2

A COMPREHENSIVE PAVEMENT
EVALUATION SYSTEM: APPLICATION
TO CRCP

E. J. Yoder
A. Faiz
D. G. Shurig

Technical Paper

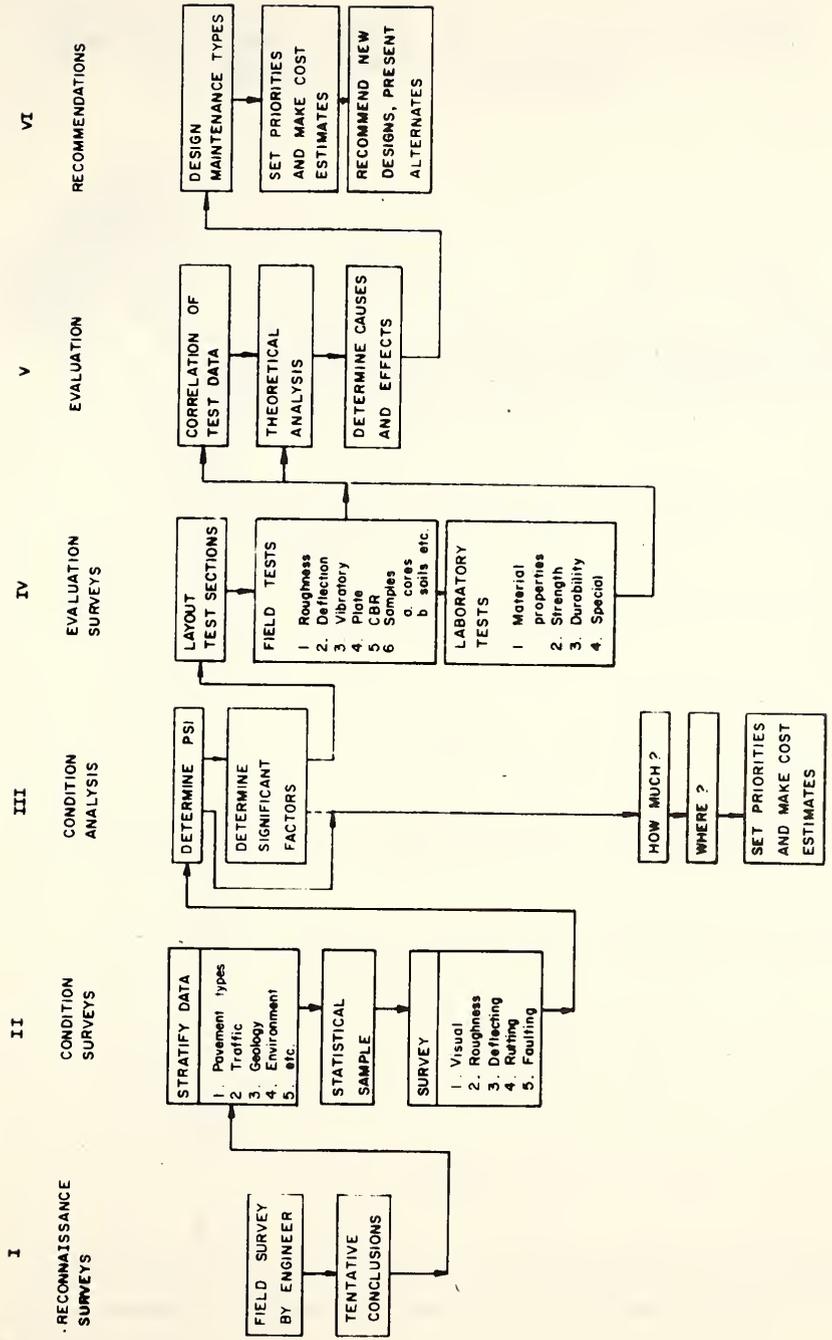
FIG. 1 SEQUENTIAL PROCESS OF PAVEMENT EVALUATION

The complete system encompasses all of the steps defined above and permits an evaluation of maintenance priorities concurrently with the determination of the reasons for pavement defects. Figure 1 shows the sequence that is followed in the comprehensive pavement evaluation system. This is a six-step process as outlined on the flow diagram.

The condition survey, as envisioned in Figure 1, has at its heart two principle steps. First, it is necessary to stratify the data on the basis of known conditions at the site. Second, each of the strata are statistically sampled and only parts of the road sections are actually surveyed. Hence, stratification of the data along with a statistical sampling procedure immediately dictates that a statistical analysis be made of the data.

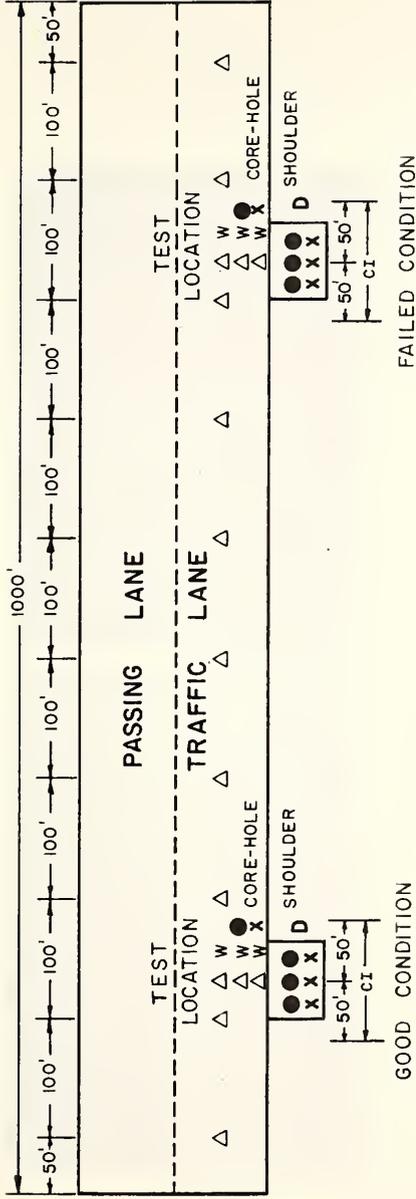
FIG. 3 TYPICAL LAYOUT OF TEST SECTIONS (NOT TO SCALE)

The typical layout and the data collected at each test section are outlined in Figure 3. The first step in the data collection procedure was to divide the test section into ten segments of 100-ft length each. Where possible two test locations, corresponding to failed and good pavement conditions respectively, were selected within each test section. A failed-test location was defined as one showing distress, indicated by a patch or a breakup. Conversely, a good-test location was defined as one showing no apparent distress. Two test locations were also used in test sections, which did not show any indication of a failure. One location corresponded to an area with a uniform and evenly spaced crack pattern while the other was representative of an area with a relatively more dispersed and nonuniform transverse cracking. These crack patterns were evaluated subjectively by visual examination. In certain sections without failures,

Deflection Measurements: Pavement deflections were evaluated with the Dynaflect (11,12). At the center of each 100-ft segment two deflection measurements were taken, one at a crack position, and the other at the mid-span position between two transverse cracks. These measurements were taken along the center line of the traffic lane, by using only the sensor between the steel wheels.

A second set of deflection measurements were obtained by using all the sensors and were taken: across the traffic lane, at 1.0 ft, 3.5 ft, and 6.0 ft from the outside pavement edge, approximately corresponding to the outside edge, the right wheel path and the lane centerline positions, respectively. The transverse deflections were determined at both a crack position and an adjacent mid-span position between two transverse cracks.

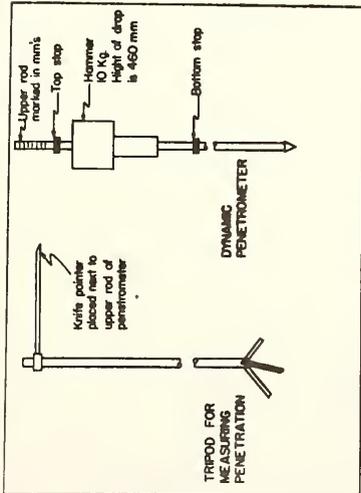
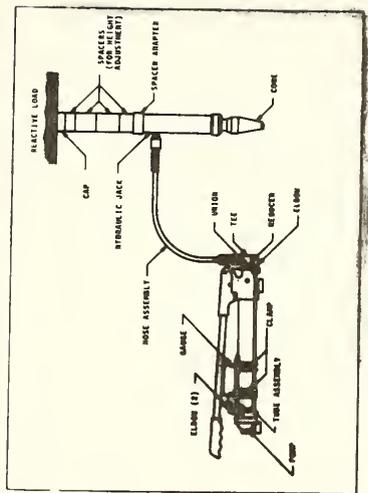
FIG. 4 TWO METHODS OF RAPID CBR TESTS
(FROM YODER AND GADALLAH)

(g) DYNAMIC CONE (FINE GRAINED SOILS)

(n) HIGH LOAD CONE (GRANULAR SOIL)

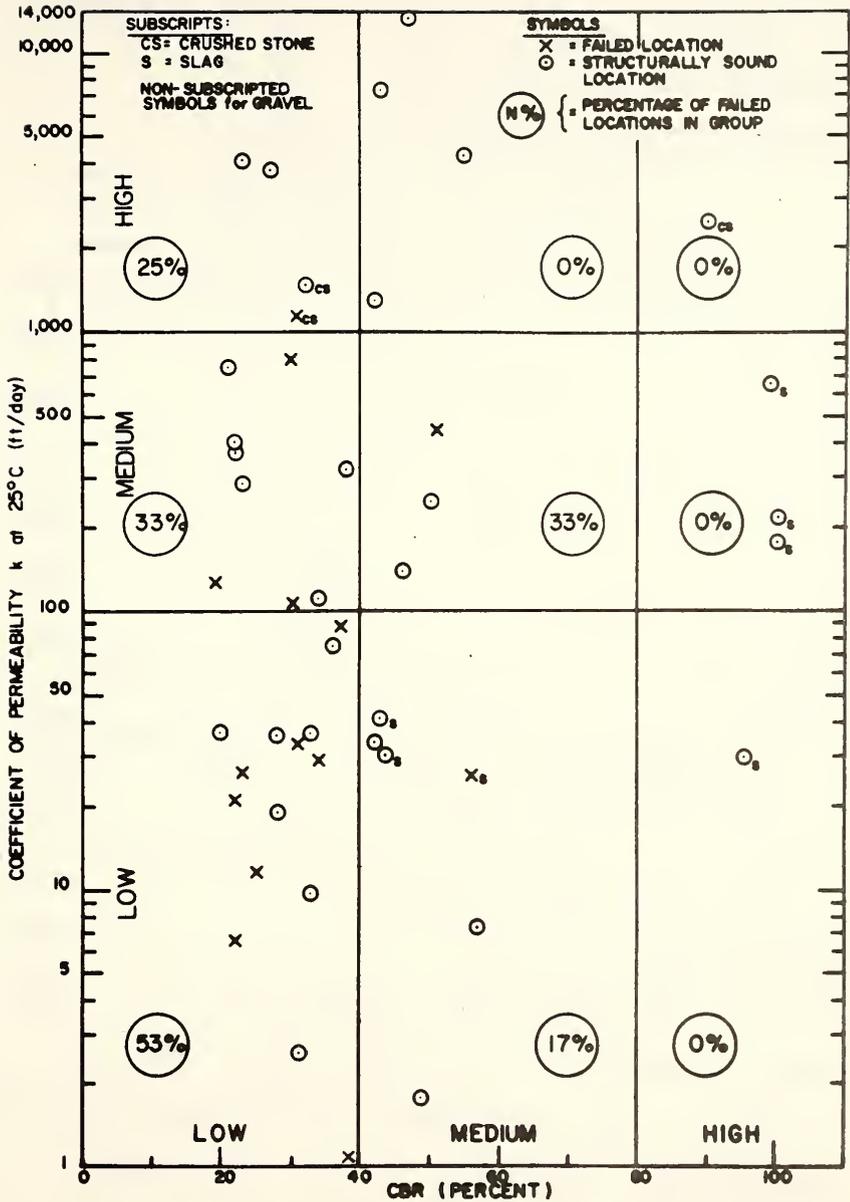
FIG.5 EFFECT OF SUBBASE STRENGTH AND PERMEABILITY ON CRCP PERFORMANCE

to note that concrete pavement performance is also a function of the interaction between subbase permeability and strength (CBR). In Figure 5, the estimated field permeability values are plotted against field subbase CBR values measured at the shoulder-slab interface. These values pertain to 46 test locations of the detailed field study. Test data for crushed stone and slag subbases are shown with separate indicators. In addition, values obtained at failed-test locations are differentiated from the values at good-test locations. The data were grouped in nine categories corresponding to three levels each of subbase CBR and permeability. For low subbase strength (CBR < 40 percent), mainly gravel subbases, the percentage of failed test locations decreased from 53 percent in the low permeability group ($k < 100$ ft/day) to 25 percent in the high permeability group ($k > 1000$ ft/day). For medium subbase strength (40 percent < CBR < 80 percent), no failures were observed where permeability was greater than 1000 ft/day. Where subbase strength (CBR > 80 percent) was high (applies only to slag and crushed stone subbases) no failures were indicated irrespective of permeability.

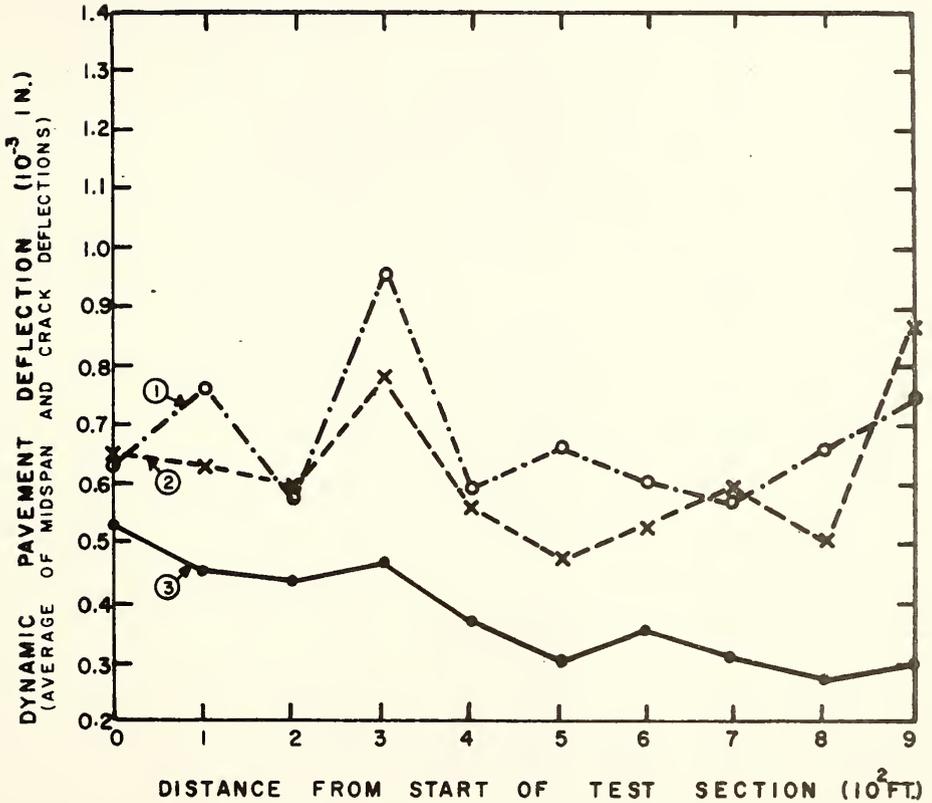
FIG. 6 DEFLECTION PROFILES OF TEST SECTIONS WITH GRAVEL SUBBASE.

Figure 6 shows the deflection profiles developed from deflection measurements made at 100-ft intervals on three test sections with gravel subbases. The values shown are the average of crack and midspan deflections, measured 6.0 ft from the pavement edge. Profiles No. 1 and No. 2 apply to two test sections, separated by the median strip, on Construction Contract R-7677, Interstate Highway I-65. At the time of the field study, the test section with deflection profile No. 2, had four concrete patches and four breakups and substantial edge pumping was indicated over the section. The test section on the opposite lanes, illustrated by deflection Profile No. 1, had no breakups, patches or any other indication of significant distress, although extensive edge pumping was observed. Yet the deflection Profile No. 1 exhibits higher overall deflections than the Profile No. 2. This is explained with reference to the Profile No. 3, obtained at a test section on Contract R-7913 (I-65). This latter contract has been completely free of distress in spite of having been under traffic since 1970. Deflection Profile No. 3 represents excellent pavement condition as indicated by deflections of a relatively small magnitude (less than 0.50 milli-in.). This should be the deflection pattern of a pavement giving good performance. The deflection pattern given by Profile No. 1 signified potential trouble, although no physical distress was indicated at the time of the field study. The high deflections

reflect loss of support caused by the erosive action of pavement pumping and/or consolidation. Under the action of repeated loads, it becomes a matter of time before distress will be manifested in the form of breakups. After extensive pavement distress, the discrete segments of the broken continuous slab attempt to conform to the shape of the pumped subbase that had developed voids earlier. This settlement of the pavement slab can be observed by visual inspection of a failed location. The deflections observed at this stage are smaller than those before the breakup because now the slab is again in contact with the subbase and has regained some of the lost support. This is the condition shown in Profile No. 2.

As a rule, sections of pavement showing signs of potential distress had higher deflections than those that had already failed (Profile No. 1 vs Profile No. 2 in Figure 6). Hence, it was concluded that pavement deflection is a good indicator of potential distress. The pavement represented by Profile No. 1 has recently shown extensive distress.

CURVE NO.	HWY.	CONTRACT	STATIONS
①	I-65	R-7677	976+00 - 985+00 EBL
②	I-65	R-7677	976+00 - 985+00-NBL
③	I-65	R-7913	731+00 - 780+00 SBL
